Use of LiDAR and Thermal Images for Bridge Deck Inspection

Presentation Prepared for:
ITS Alaska 2024 Annual Meeting

The main goal of the study is to develop practical AI (**computer vision**) tools that help bridge inspectors with defect detection and quantification, and automate inspection reporting. The focus is on **bridge deck delamination**.

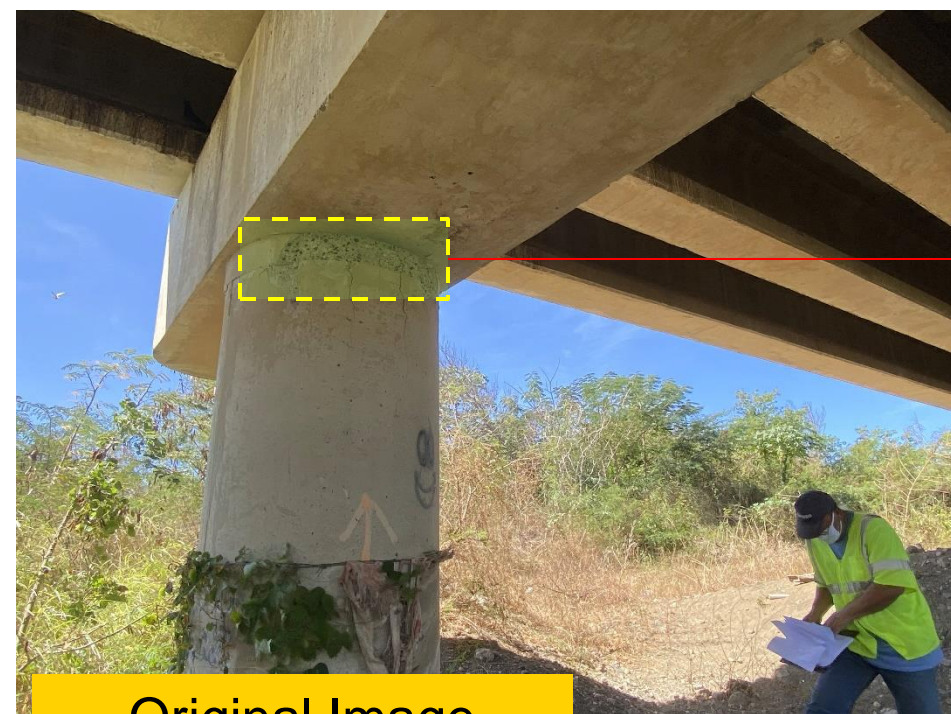
Original Image

Segmented Image

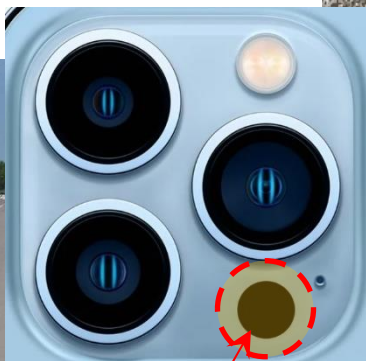
Lidar Camera

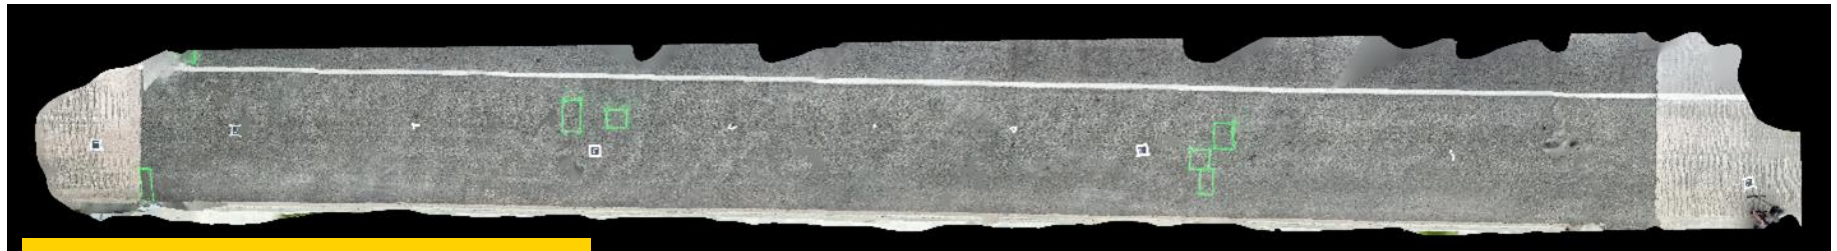
2D Map of Bridge Deck

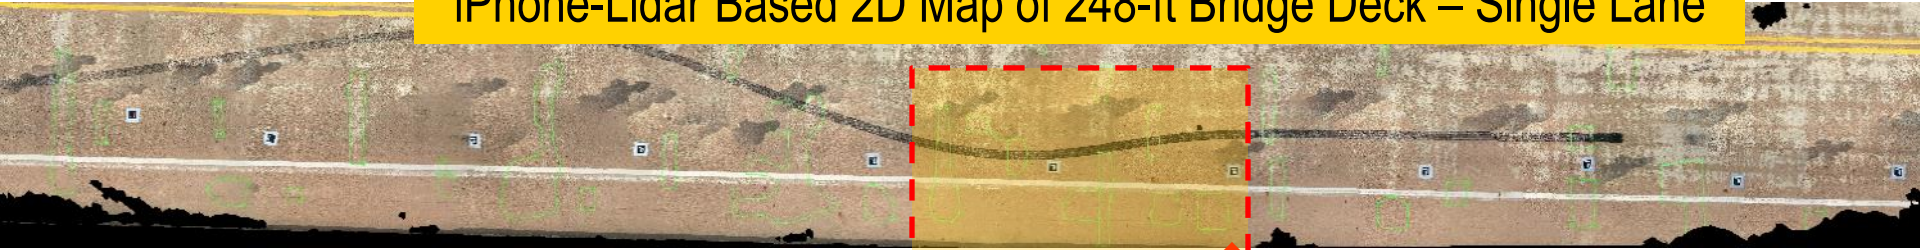
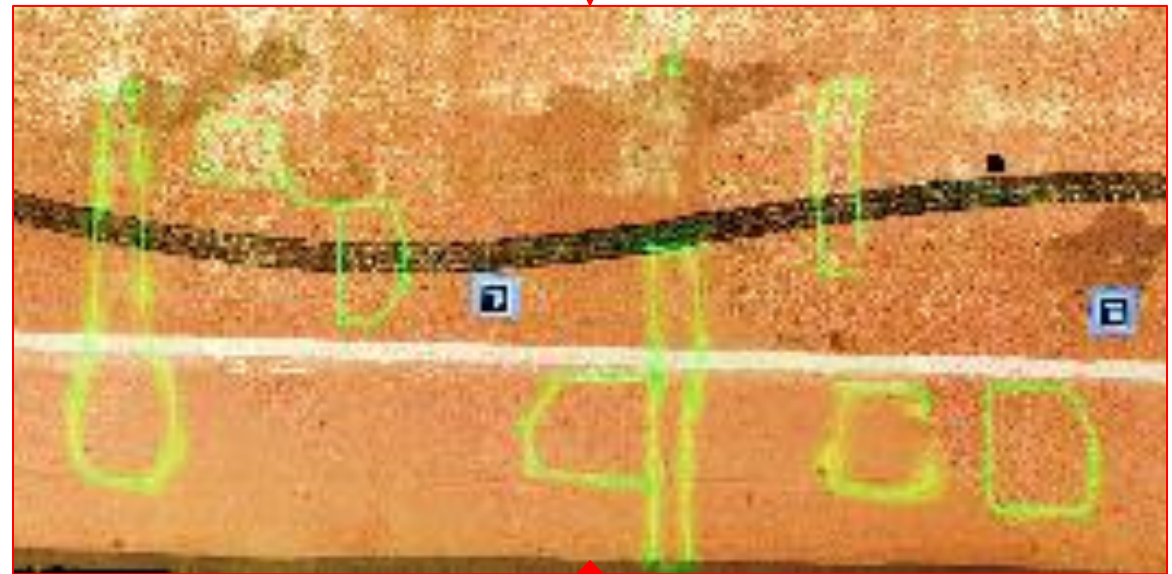
iPhone-Lidar Based 2D Map of 248-ft Bridge Deck – Single Lane

- Inspected 45 bridges
- 11,551 RGB photos
(training 70,000)
- 40 lidar maps

AI (U-Net) Prediction

99% Accuracy
on 18 Bridges

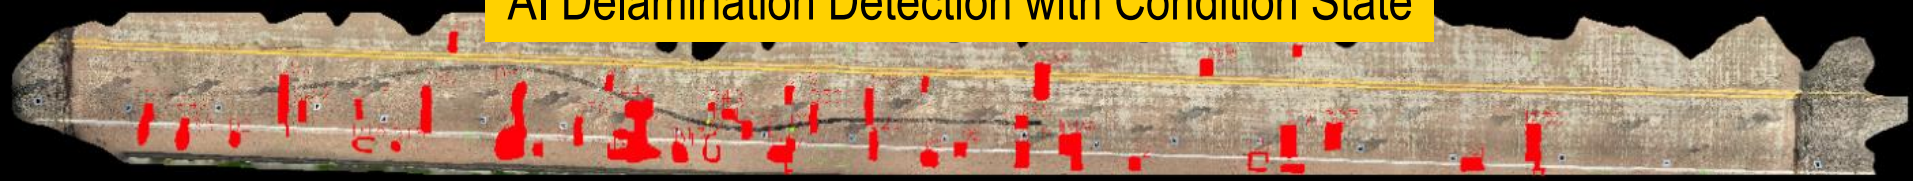
iPhone-Lidar Based 2D Map of 248-ft Bridge Deck – Single Lane

AI Delamination Detection with Condition State

Proposed Condition States for Delamination in Concrete Decks

Defects	CS 1	CS 2	CS 3	CS 4
	Good	Fair	Poor	Severe
Delamination, Spall, or Patched Area (1080)	Defected area is less than or equal to 7 in ² (45 cm ²)	Defected area is greater than 7 in ² (45 cm ²) but less than 30 in ² (195 cm ²)	Defected area is greater than 30 in ² (195 cm ²) but less than 110 in ² (710 cm ²)	Defected area is greater than 110 in ² (710 cm ²)

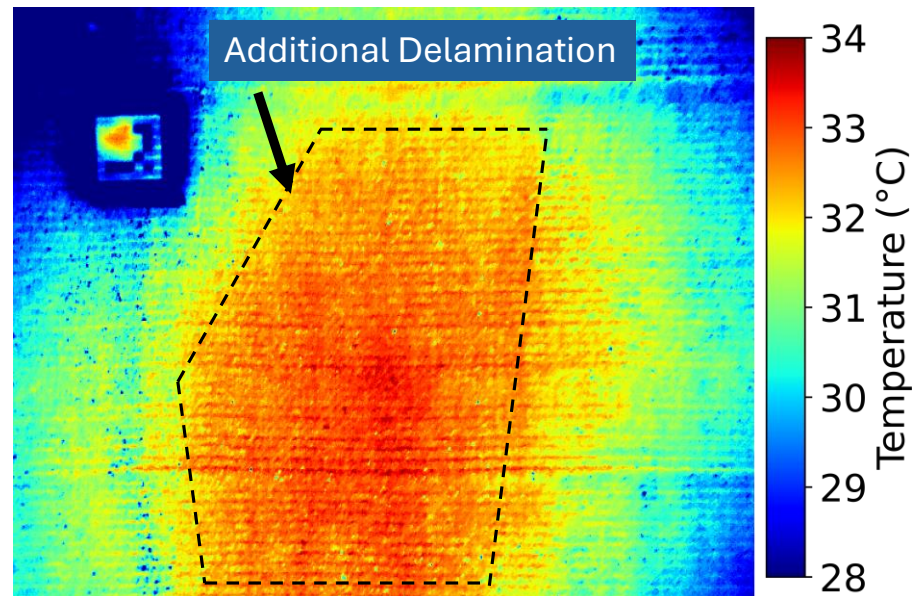
Sample of Thermal Data with Inspector-found Delamination and Additional that were missed

AI Predicted Delamination from Thermal Data

- Inspected more than 45 bridges.
- Obtained more than 2,000 thermal images. Data was augmented to 5,000 for training, saved 400 images for evaluation. Used **U-Net**.

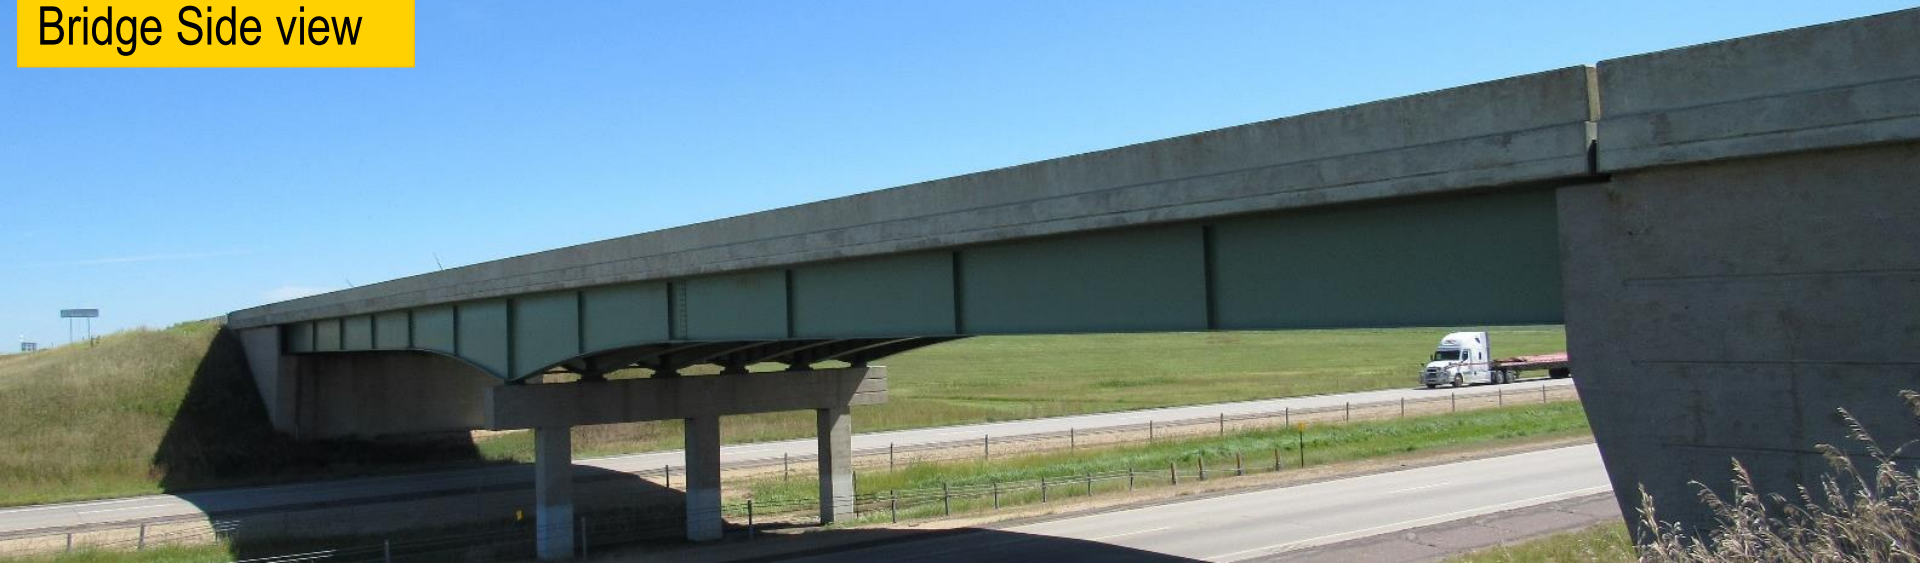
Bridge Side view

- Highway overpass
- Bridge Length = 293 ft
- Bridge Width = 44 ft.

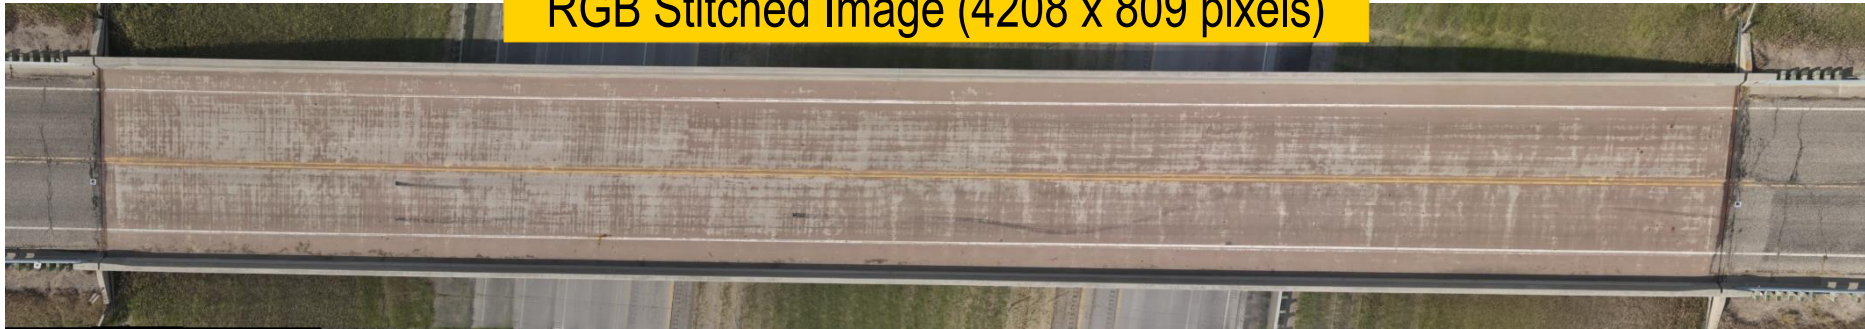
11 RGB Images at 50-ft Height

RGB Stitched Image (4208 x 809 pixels)

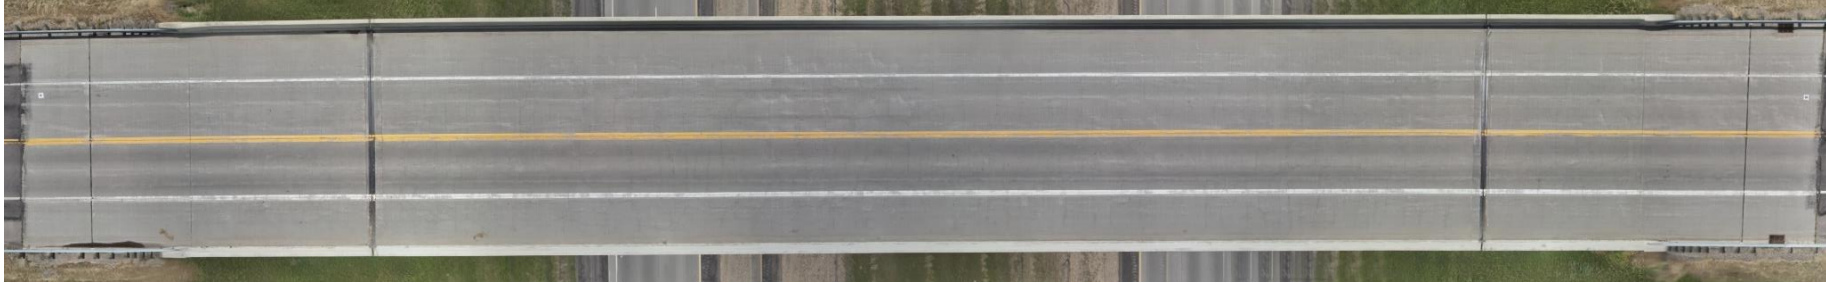
Vaulted
Abutment

RGB Stitched Image
